# This guideline helps to create a clear and transparent damage process.

### **Truck Inspection**

# Condition of individual components.

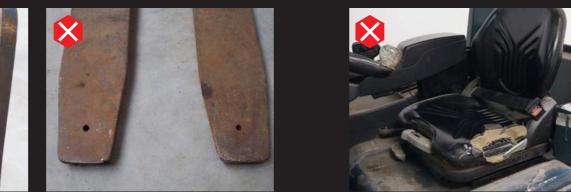
- Ruptures in greycast iron
- Mechanical changes (for example load increases)
- Connecting bolts and/or protective mesh in front of fan deformed or not present

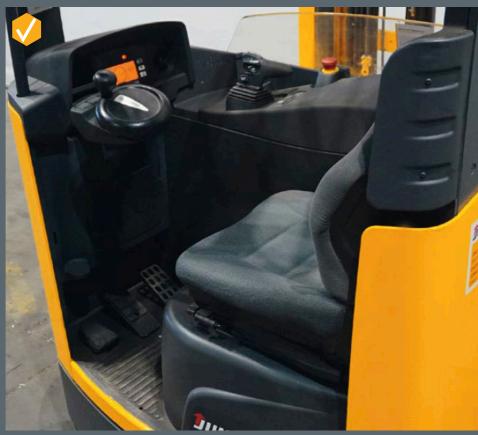
- Steering wheel and steering wheel spinner knob fully functional
- Hydraulic lever fully functional
- Control displays fully functional
- Base plate fully functional
- Panelling has no holes, cracks or broken places
- Display should be fully functional
- Dashboard should be fully functional
- Brakes: Required condition: fully functional in accordance with FEM-4.004 (certificate of conformity) (uniform response left and right during travel without any effect on the steering)

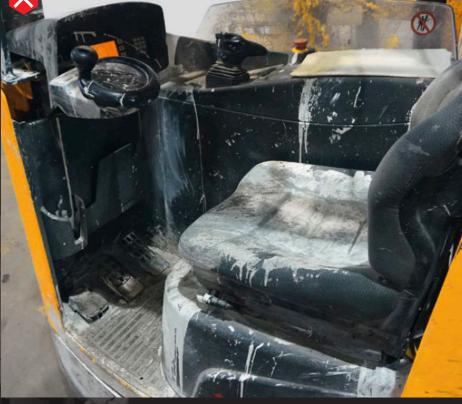
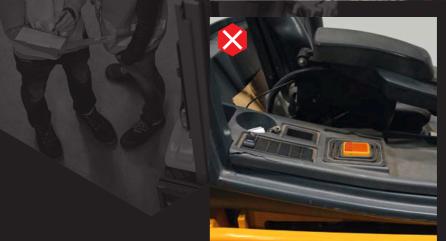
- Pieces broken out of hydraulic lever (and/or a significant amount of play)
- Control displays are not fully functional or there are significant scratches in the display
- Base plate not fully functional
- Antislip mat missing
- Panelling is damaged
- Dashboard broken, not fully funcitonal
- Bord computer not fully functional
- Display broken, poor visibility
- Brake systems not fully functional (service brake, electric motor braking, handbreak and deadman switch and tiller head switch for manually guided trucks)
- Parts of brake systems missing

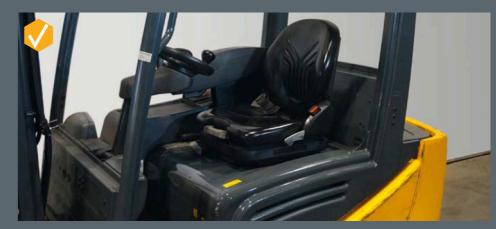
- Mechanical deformities on bearing parts
- Overhead guard or struts for overhead guard deformed
- Plastic parts have pieces broken out or other significant deformities
- Significant residue of stickers or even paint that has been applied
- Mechanical deformities on the covers

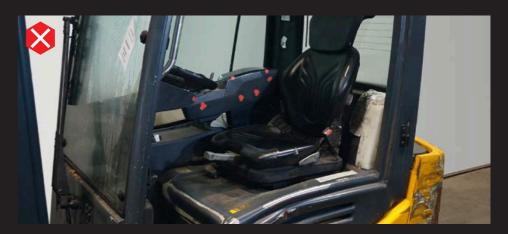
- Cabin struts and/or cabin parts (roof, doors, front window, rear windscreen) not complete, damaged and/or deformed
- Cabin door hinges warped
- Functionally restricted accessory parts
